Access Study to all Pertinent Parts of  
Dam Projects During High Reservoir  
Conditions

# Upper Connecticut Basin New Hampshire and Vermont

JULY 1992

US Army Corps  
of Engineers  
New England Division

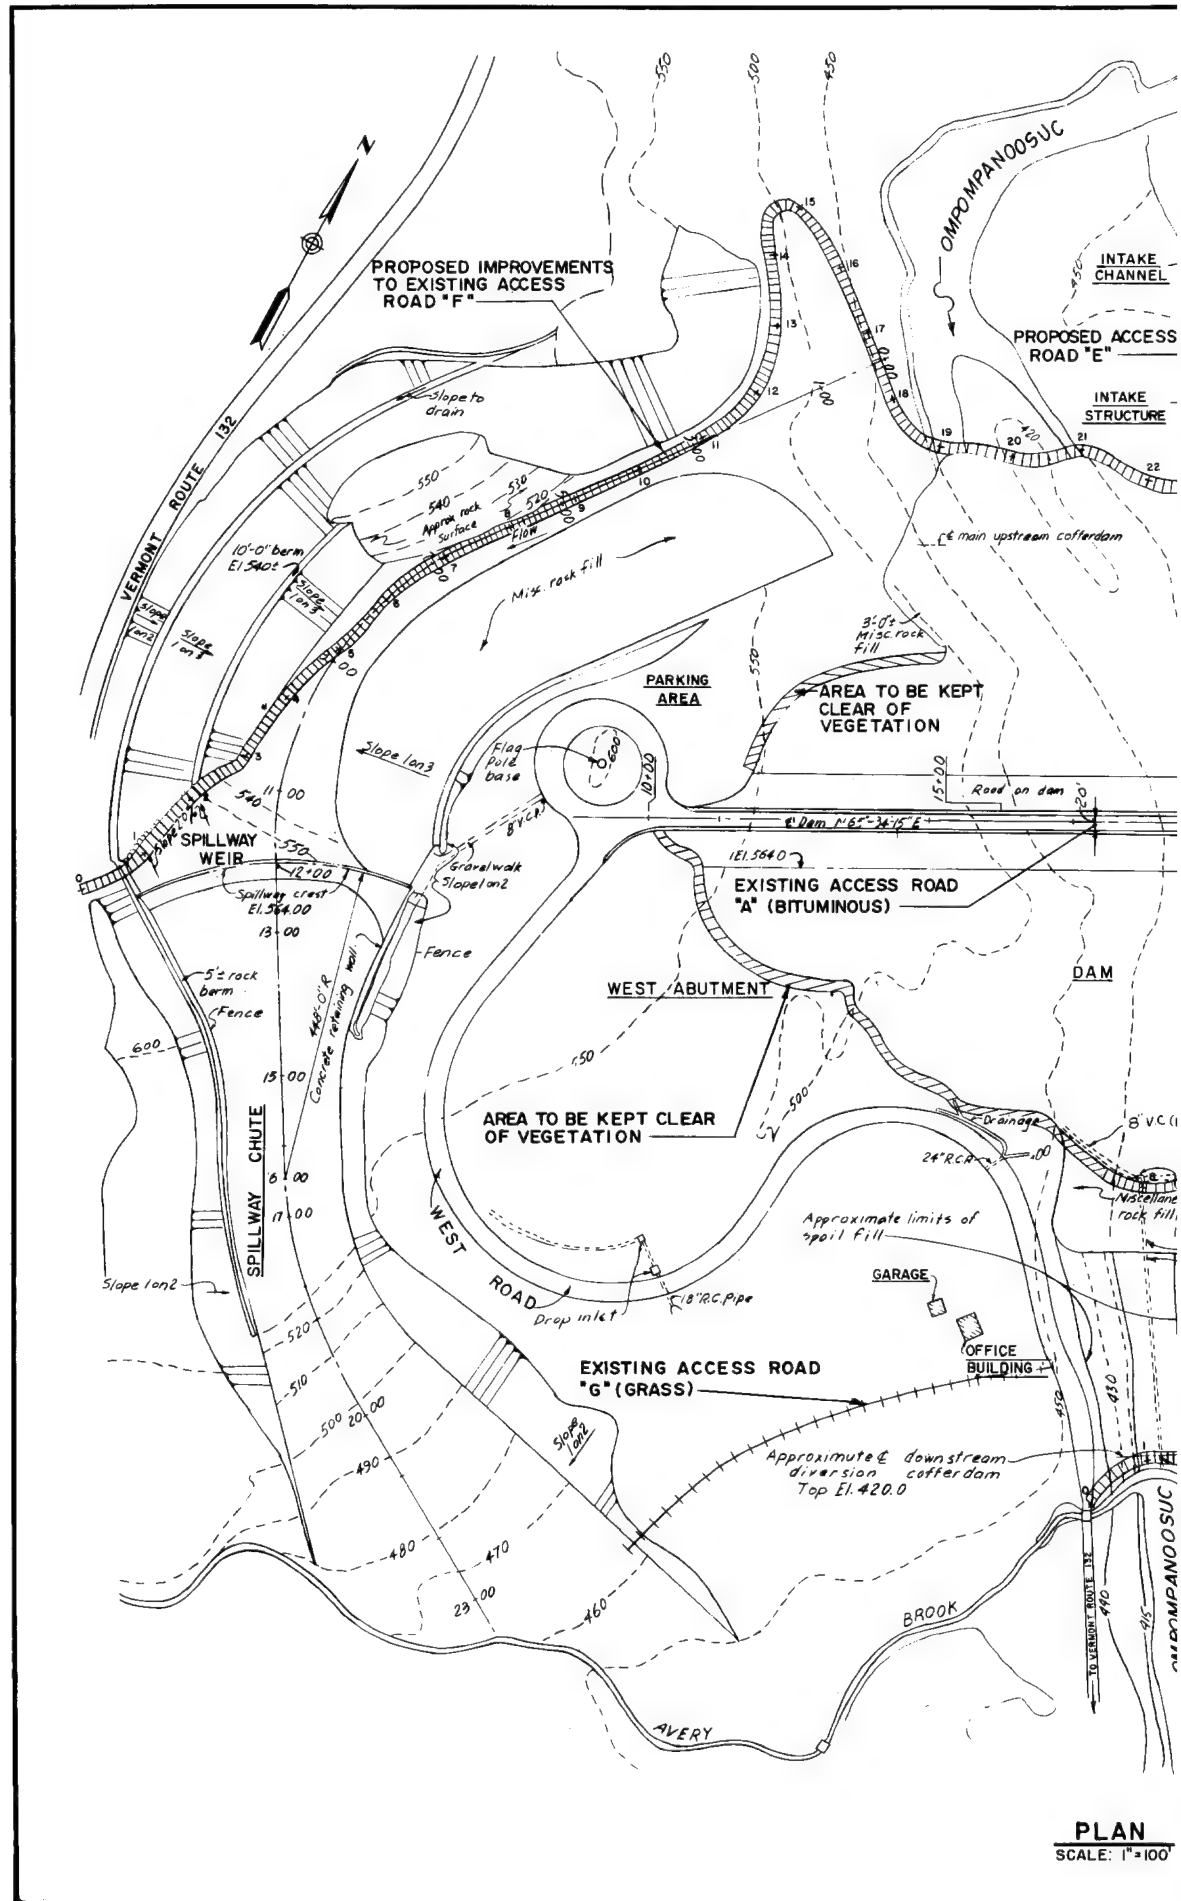
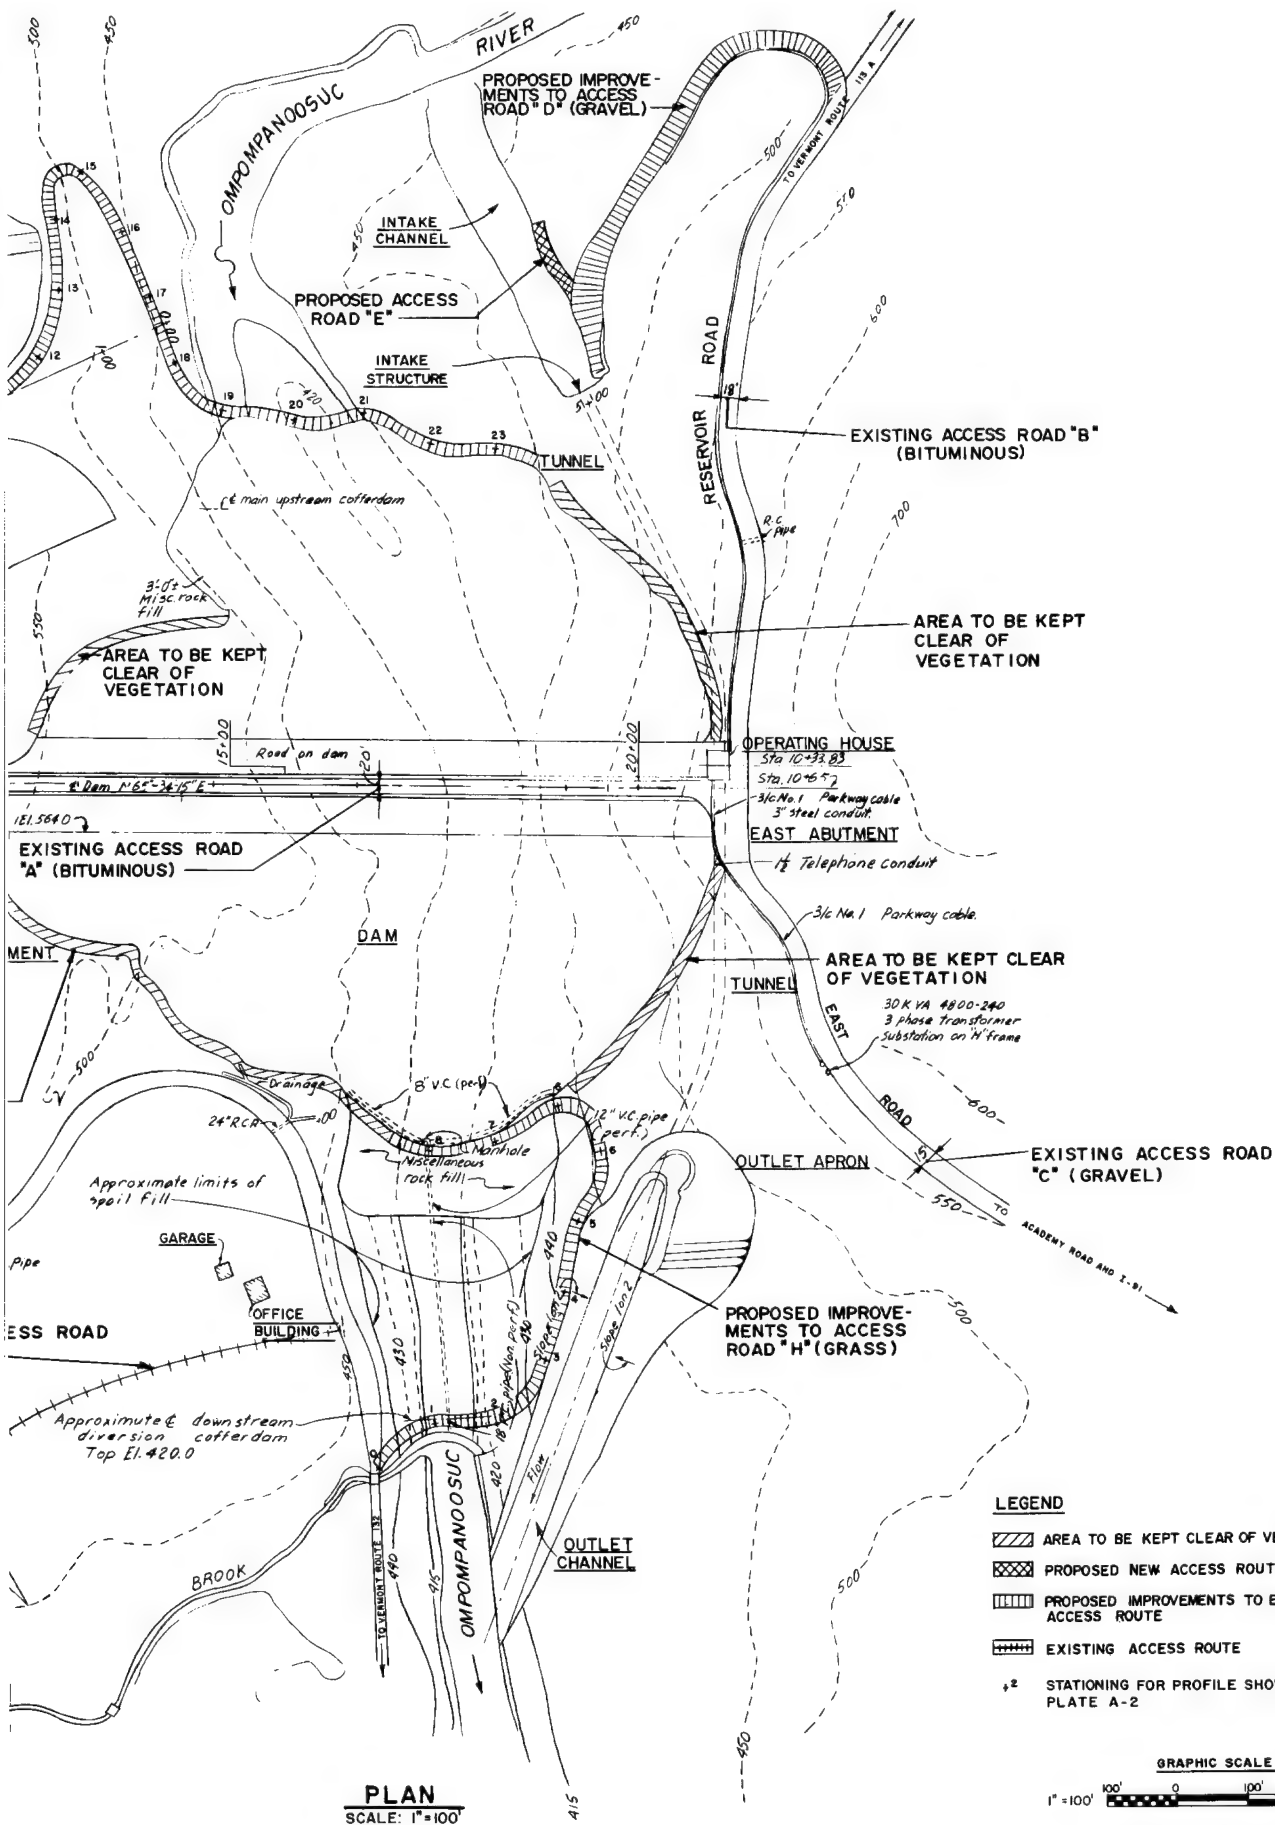
DES. BY.		EM UPPE
DR. BY.		
CK. BY.		
GEOTECH. ENG. DIV.		
PLATE A-1

3. Adequacy of Access. The grassy area in the immediate vicinity of the downstream toe does not meet design criteria. Heavy equipment would probably have difficulty operating in the downstream toe area during spillway discharge. Only equipment under eight tons in weight could reach the toe area once spillway discharge conditions occurred because of the load limitations on the Academy Road covered bridge.

6. Adequacy of Access. Access to the crest of Union Village Dam is adequate. Presently, access to the lower portion of the upstream toe of the dam is inadequate during normal pool conditions.

4. Recommended Improvements. Access Road "H" as shown on Plates A-1 and A-2 should be improved in the downstream toe area. Flattening of the gravel ramp at West Road and a steep slope on the east side of the old Ompompanoosuc River channel would be required to improve Access Road "H". The improvement would also provide better access to the outlet channel and structure. Upgrading the covered bridge on Academy Road to allow a higher load limit is beyond the scope of this study.

7. Recommended Improvements. Access Road "F" should be improved, as shown in Plates A-1 and A-2, so that the upstream toe and slope of Union Village Dam can be reached during normal pool conditions. Flattening two steep slopes and placement of a significant amount of rock fill will be required to improve Access Road "F".

10. Recommended Improvements. Access Road "D" should be cleared, grubbed, widened and surfaced with six additional inches of gravel to make it easier to use the road. Access "E" should be constructed as shown in Plates A-1 and A-2 to provide access to the north 100 feet of the inlet channel. Access Road "H" should be improved as discussed in paragraph 4 to provide better access to the outlet channel and structure.

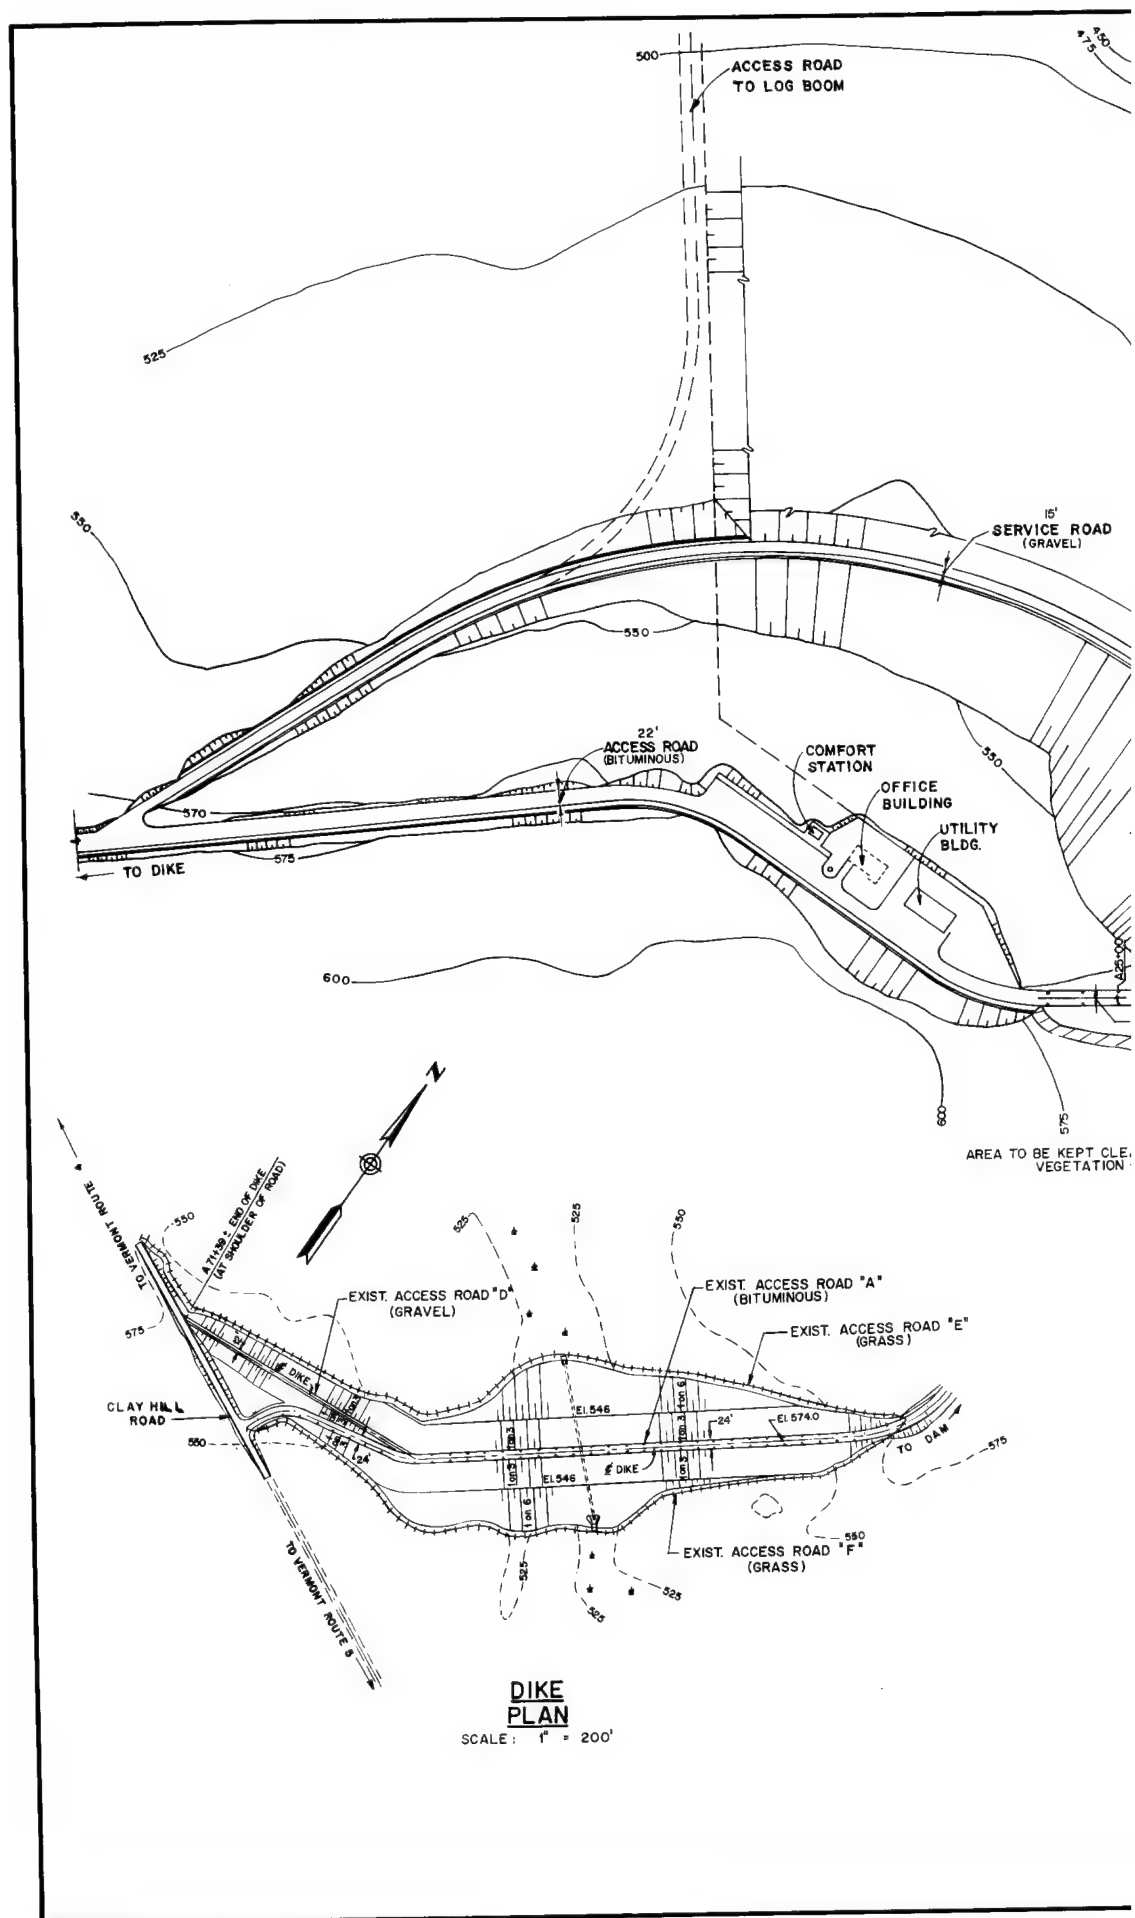
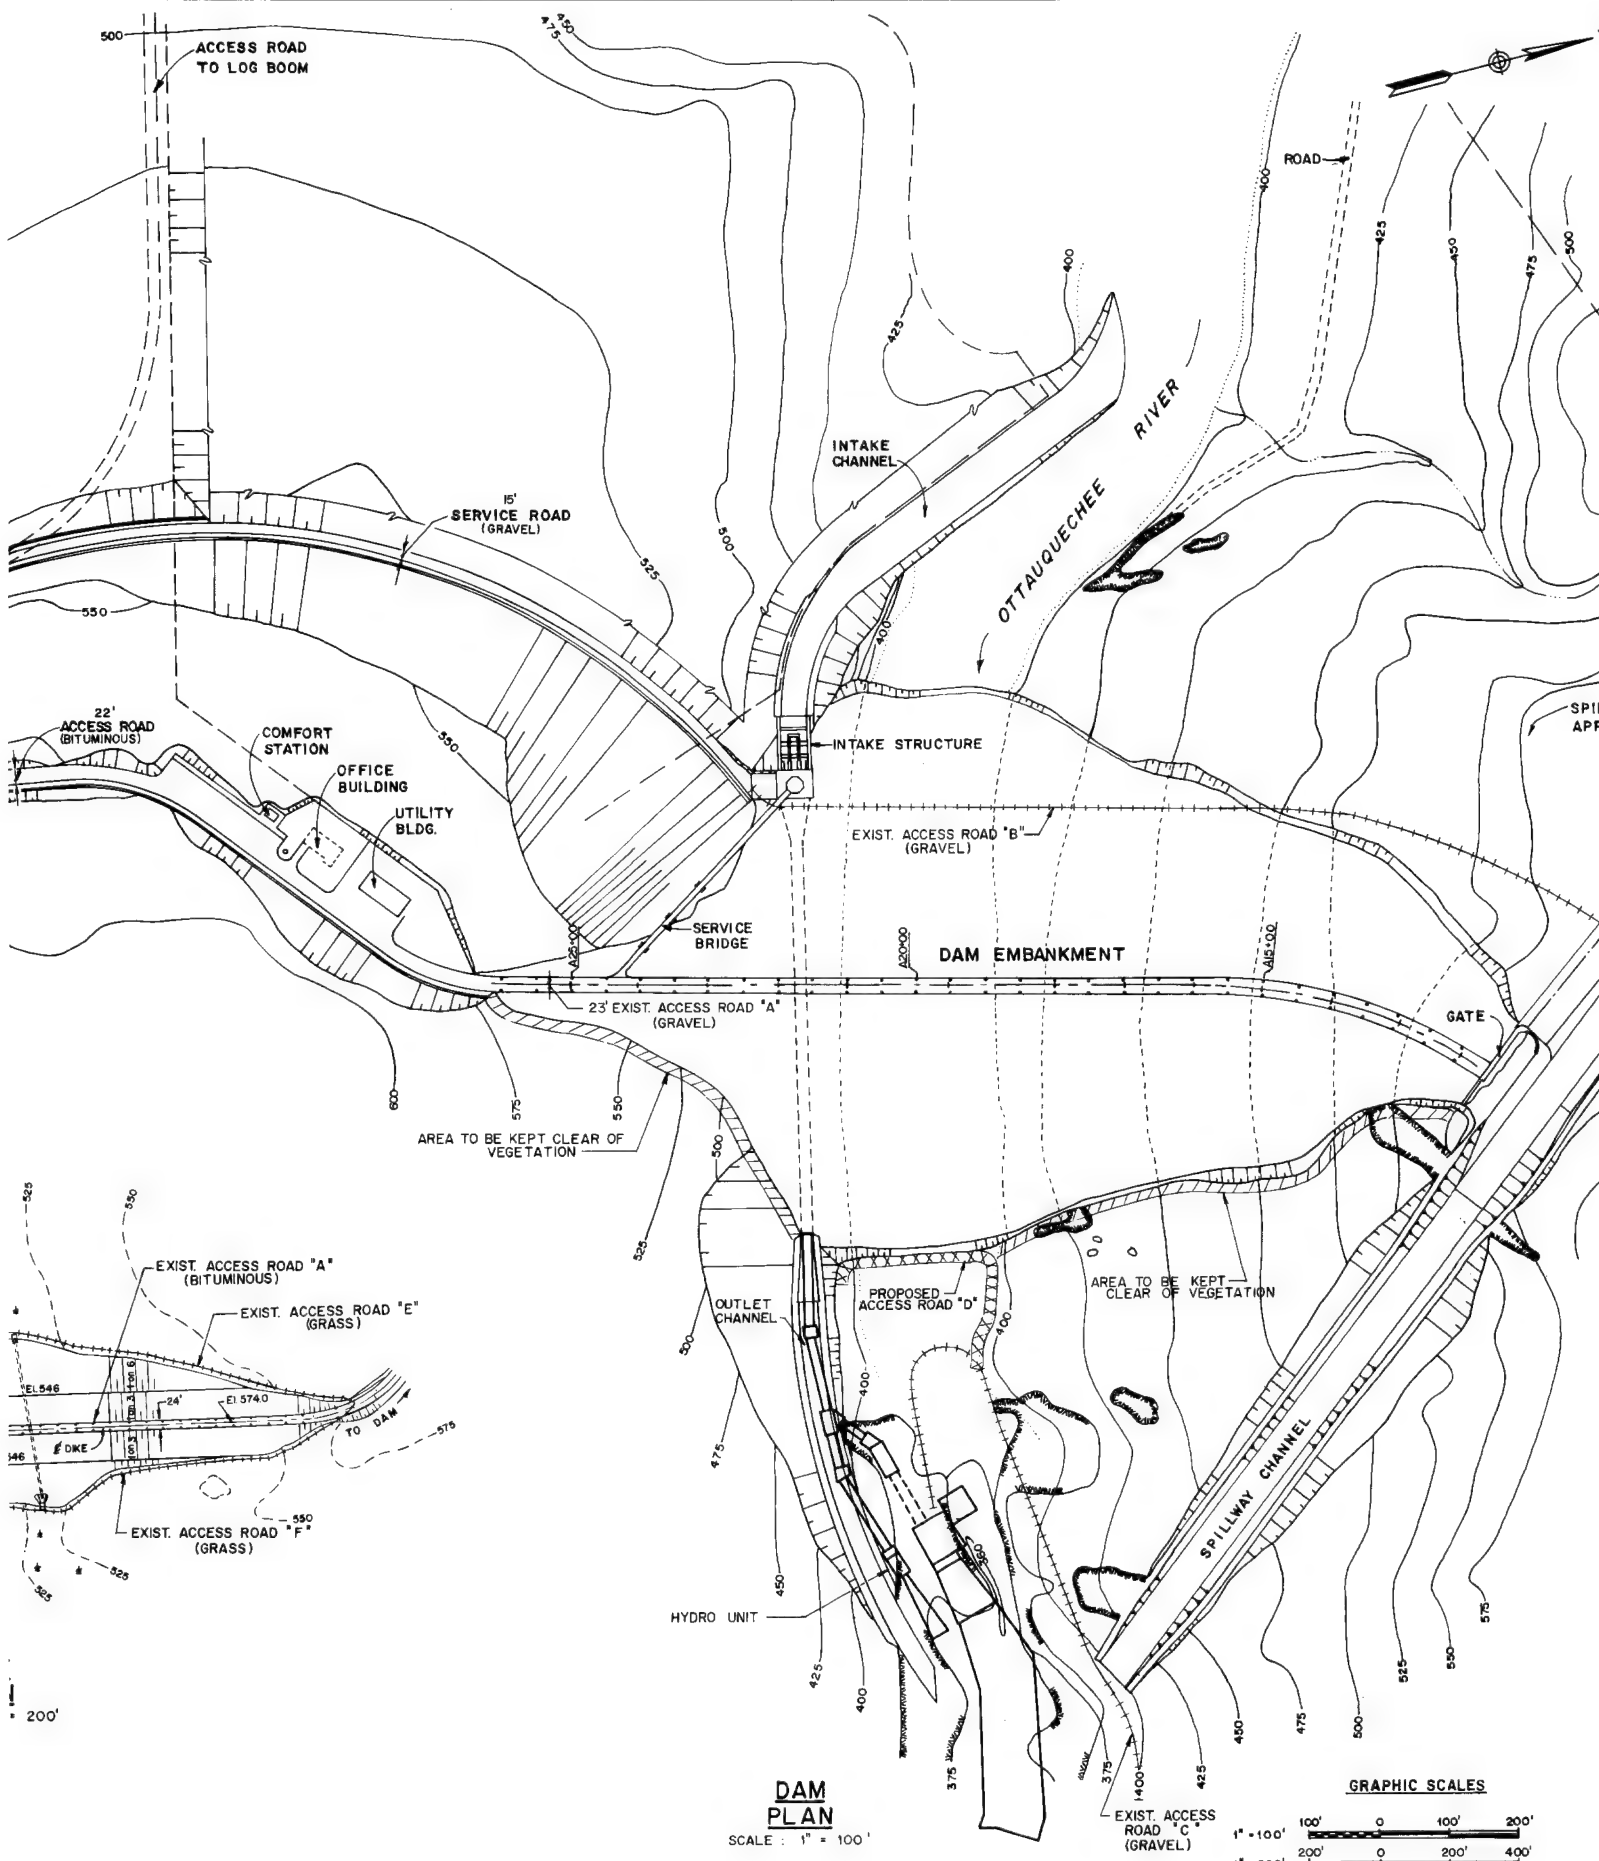
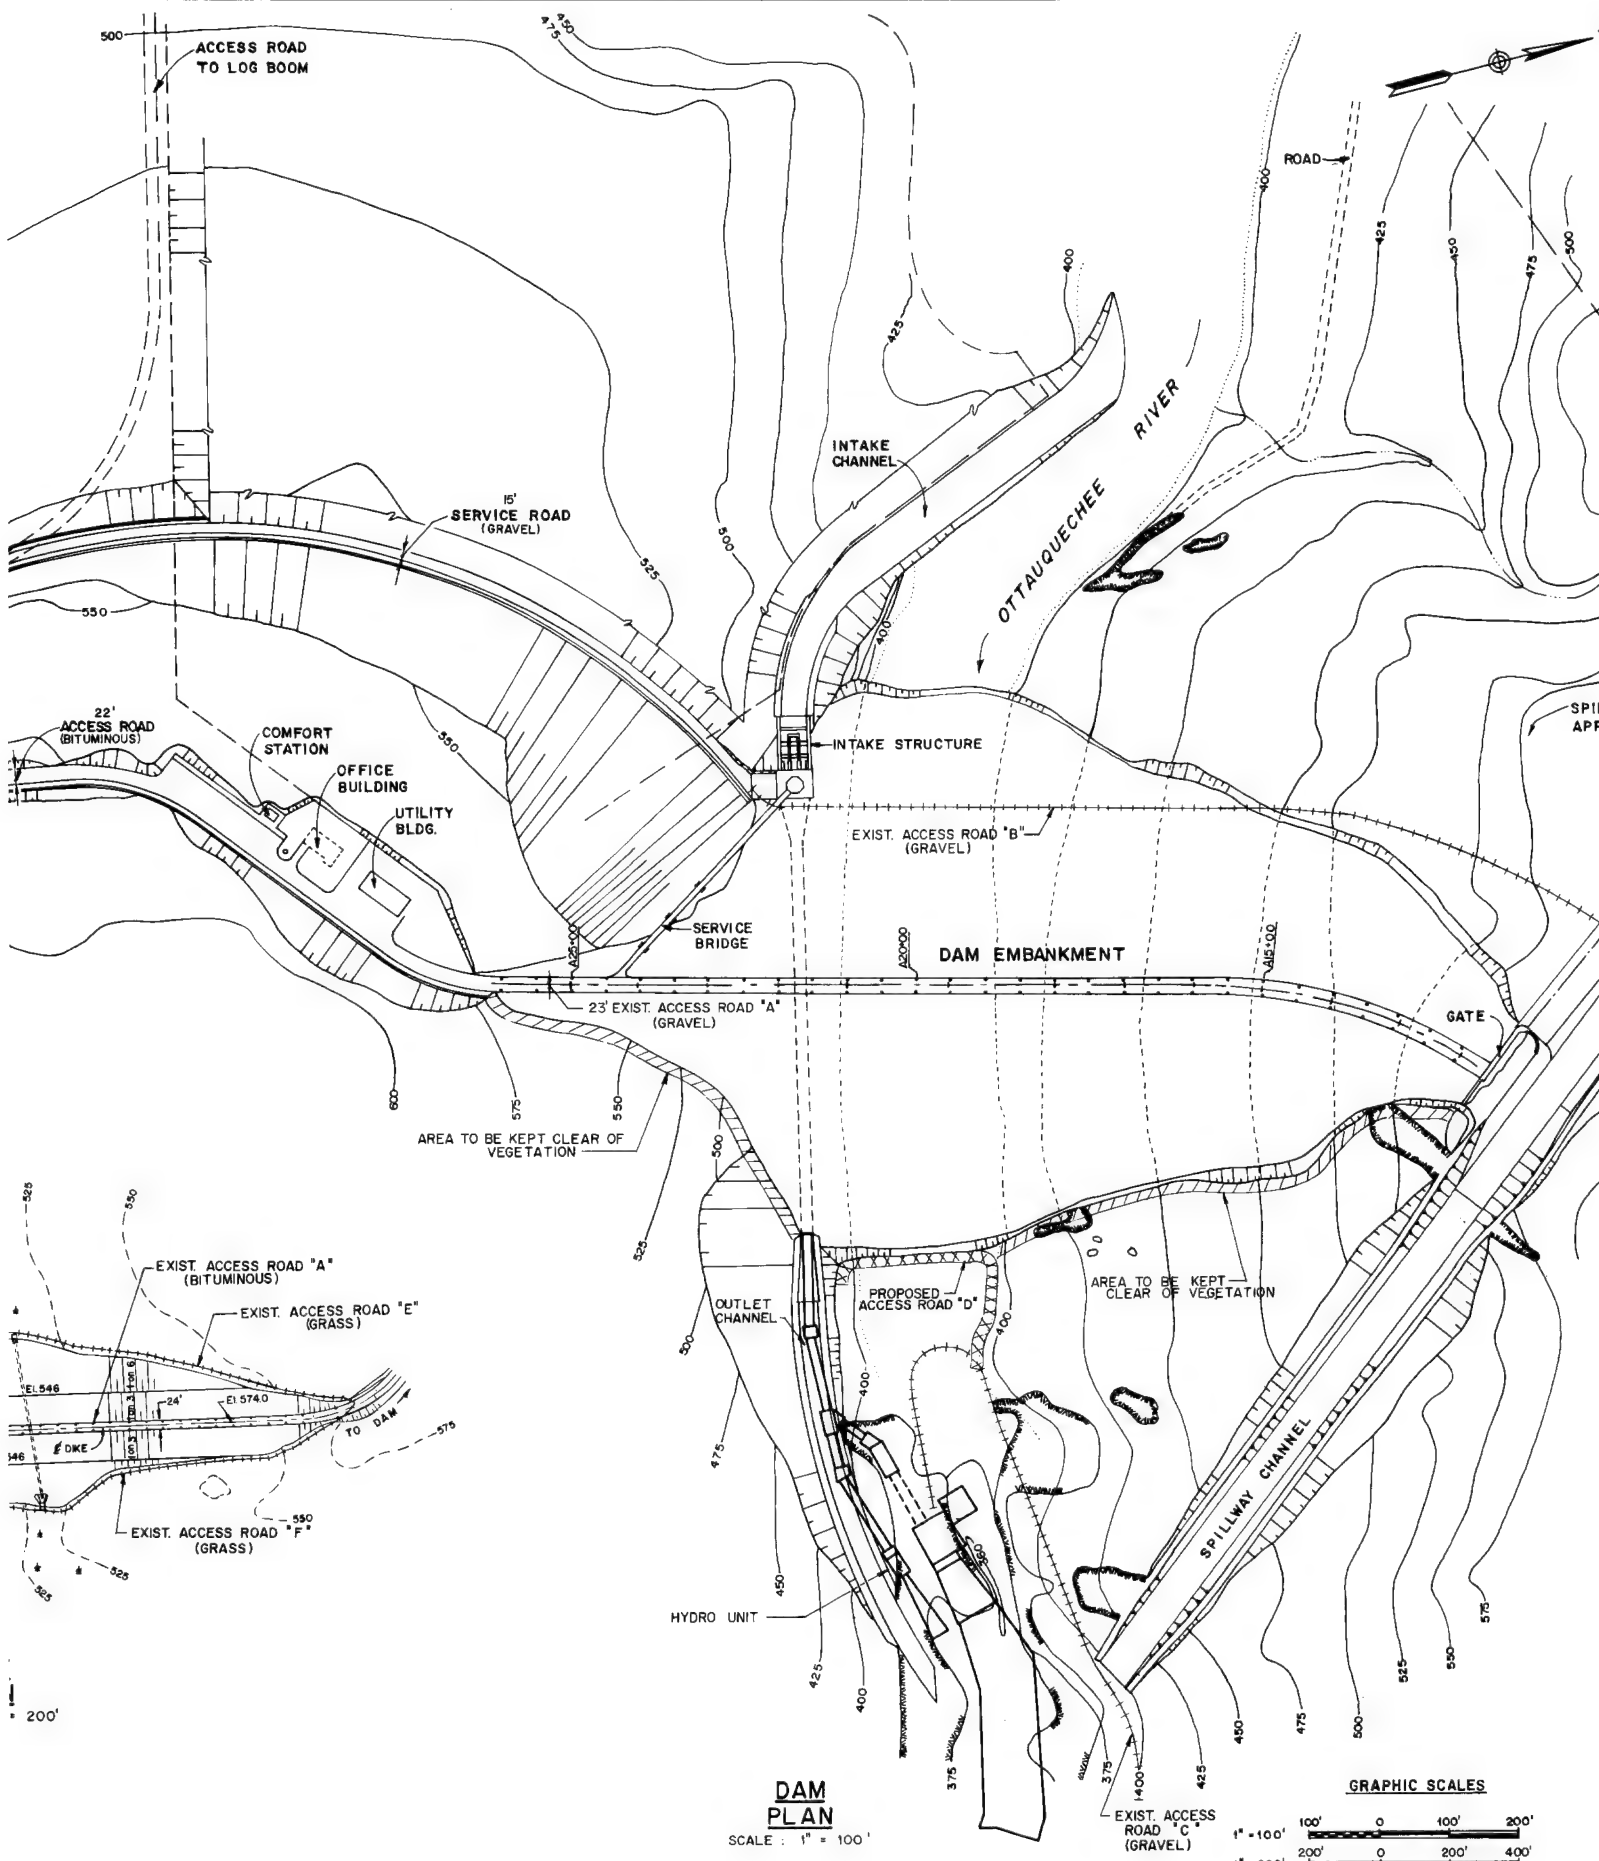
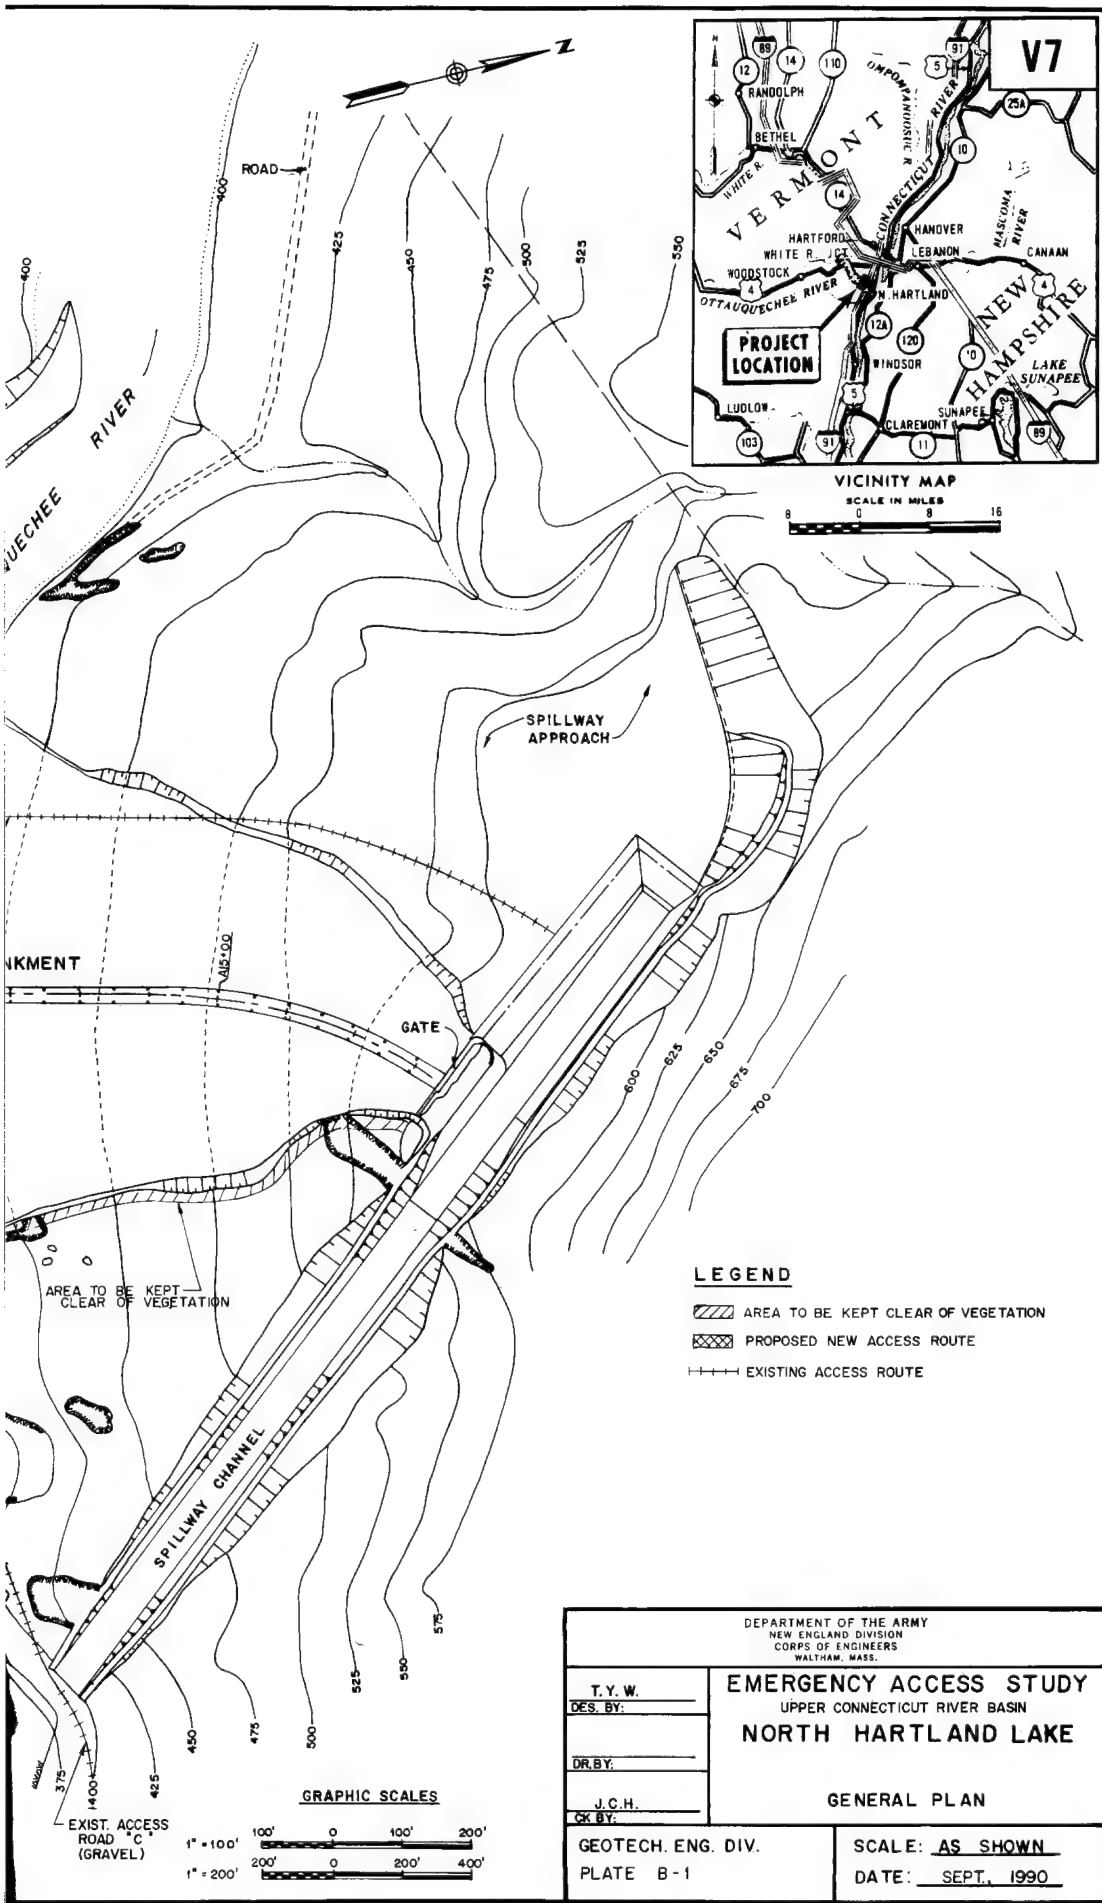
3. Adequacy of Access. Access to the downstream toe of North Hartland Dam is inadequate. Heavy equipment may bog down in the grassy downstream toe area and cannot traverse the steep adjacent abutment slopes. Spillway discharges would prevent access to the area by blocking Access Road "C". Providing access to the downstream toe during spillway discharge is beyond the scope of this study.

4. Recommended Improvements. Access Road "D" should be constructed to allow heavy equipment to reach the downstream toe of North Hartland Dam without bogging down. Access Road "D" construction would require removal of existing vegetation and soft material along the proposed road alignment and then placement of 12 inches of gravel. Vegetation should be periodically removed from the dam abutment interfaces to allow for inspection of the interfaces and light weight equipment to traverse the interfaces.

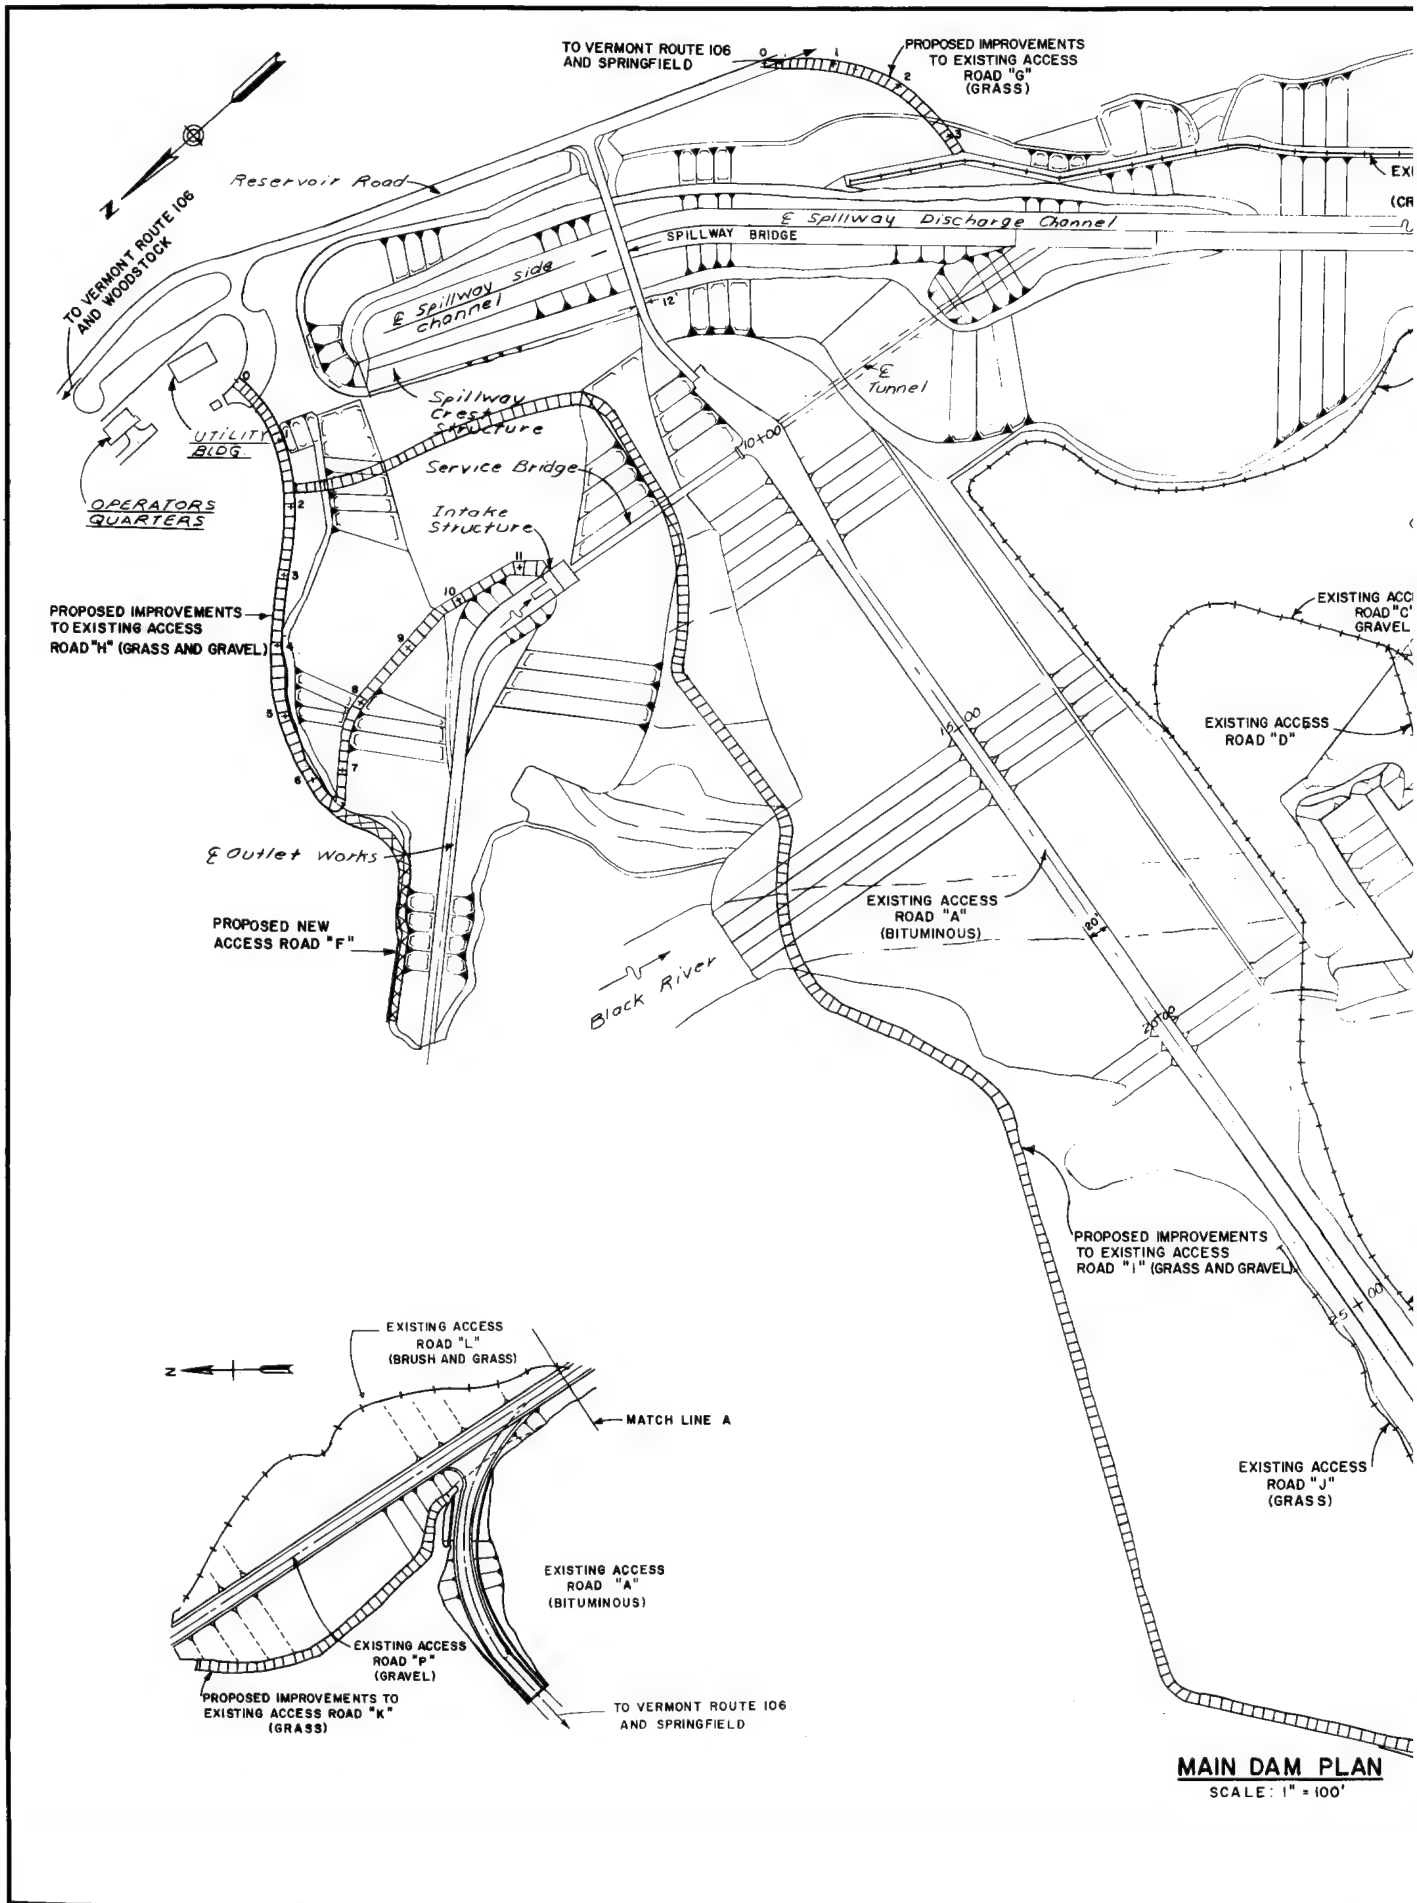
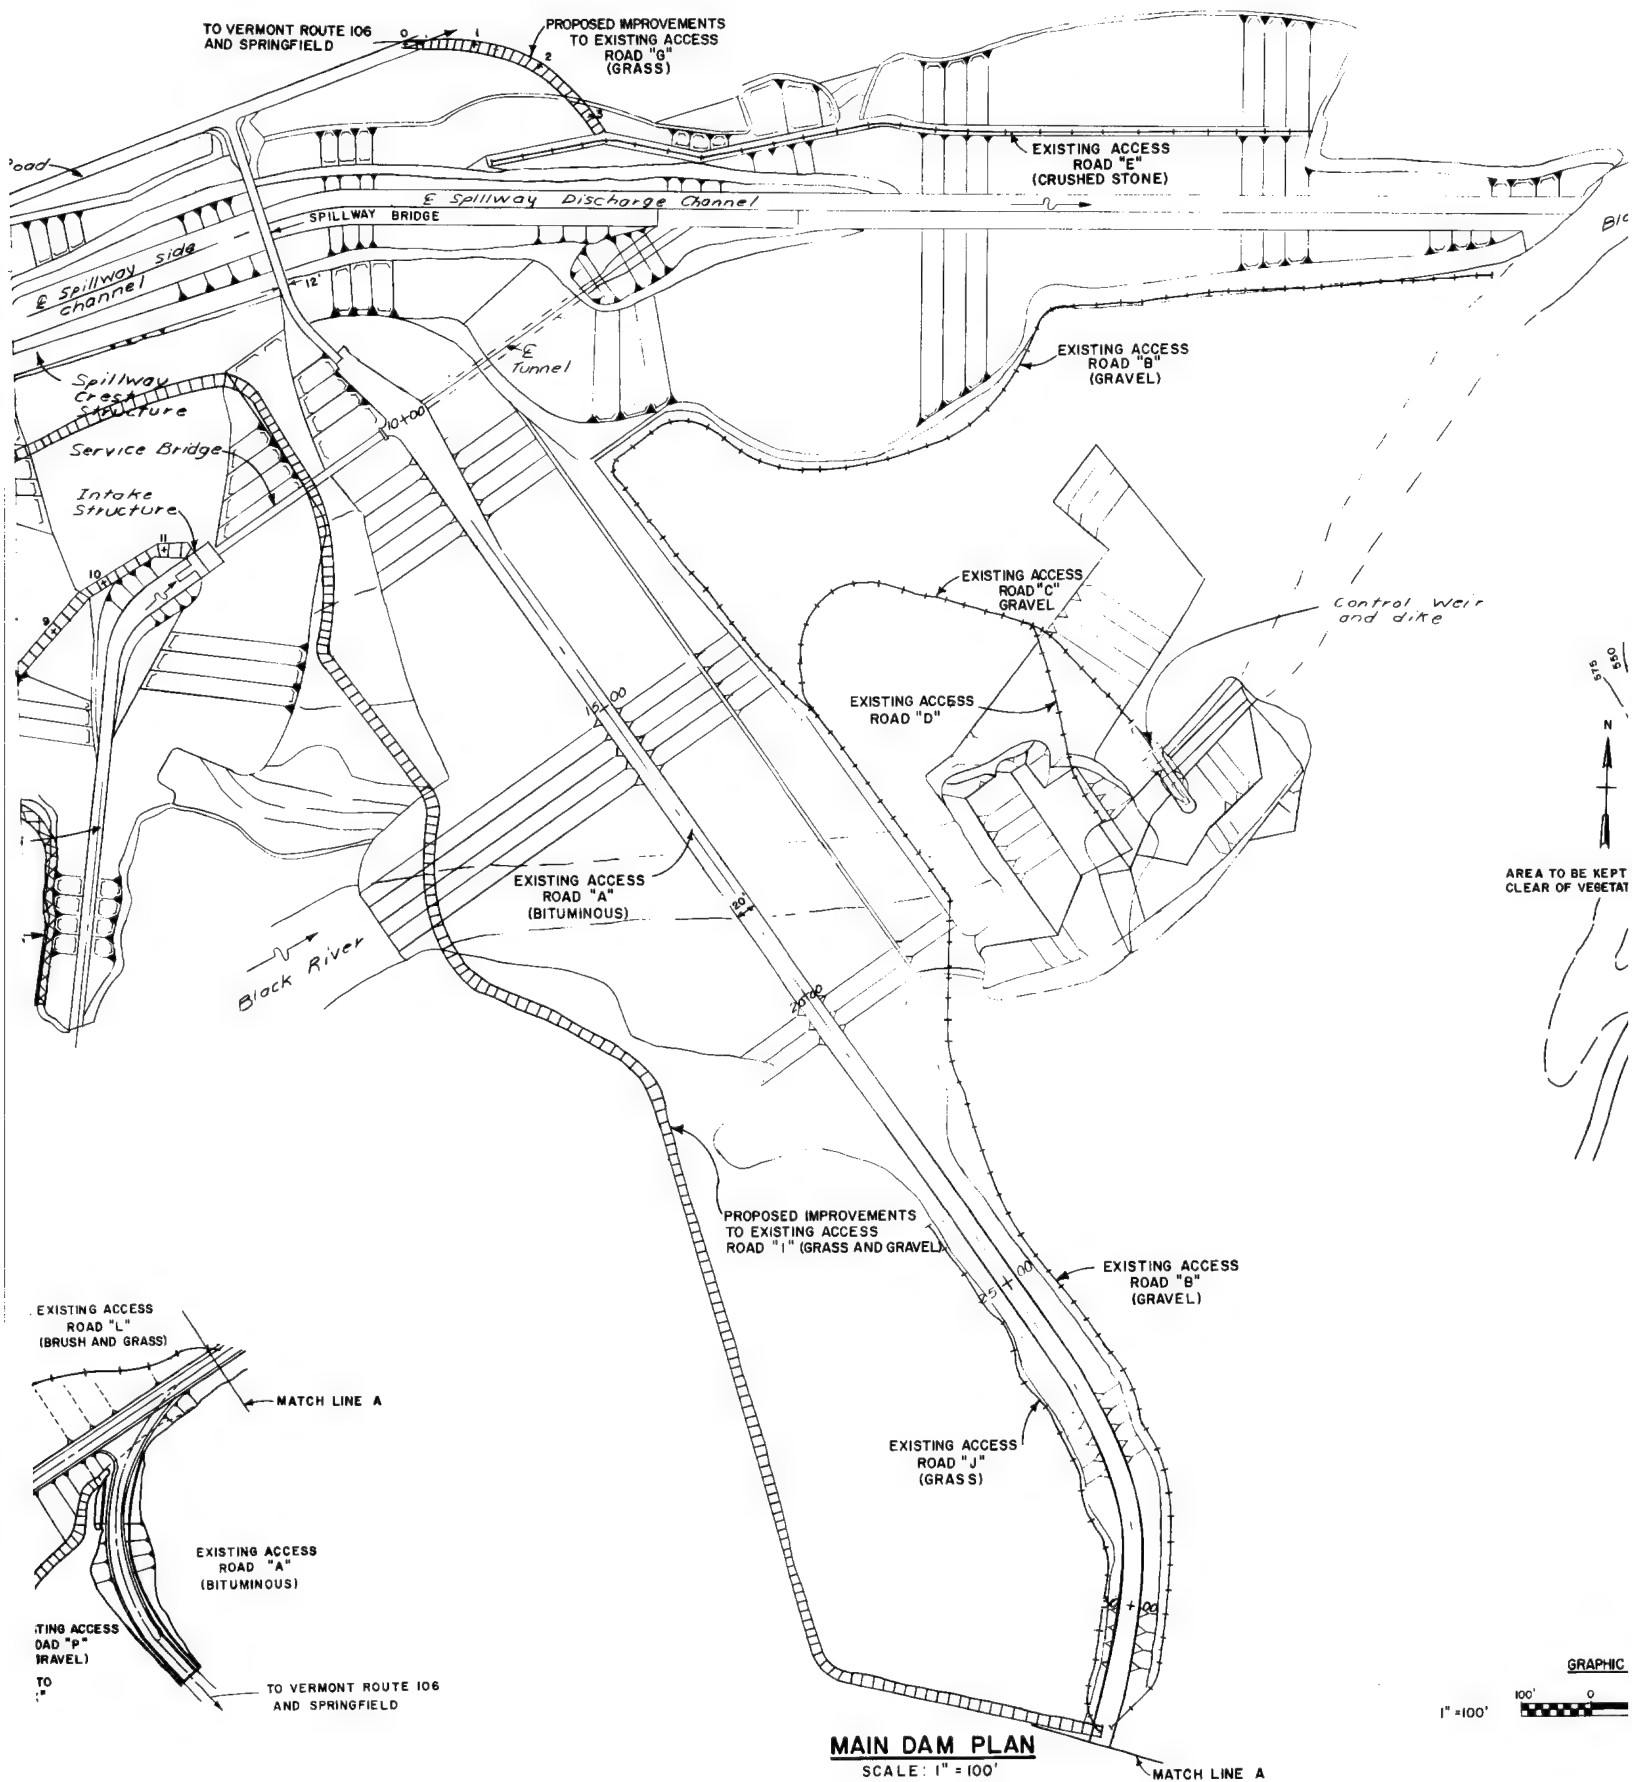
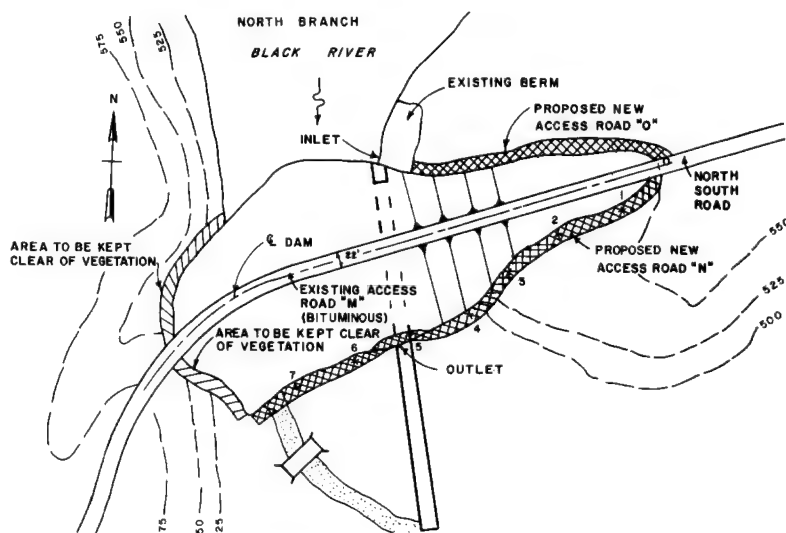
DEPARTMENT OF THE ARMY NEW ENGLAND DIVISION CORPS OF ENGINEERS WALTHAM, MASS.	
EMERGENCY ACCESS STUDY UPPER CONNECTICUT RIVER BASIN	
NORTH SPRINGFIELD LAKE GENERAL PLAN	
DES. BY: _____	
DR. BY: _____	
CK. BY: _____	
GEOTECH. ENG. DIV. PLATE C-1	SCALE: AS SHOWN DATE: SEPT. 1990

3. Adequacy of Access. The access to the downstream toe of North Springfield Dam is adequate except for Access Road "K" which has a grass surface. It appears Access Road "K" might soften during high water conditions. Then it would become difficult to operate heavy equipment on it.

9. Adequacy of Access. Access to the outlet works at North Springfield Dam is inadequate. The grass surface and steep slopes of Access Road "H" to the inlet channel and structure do not meet the design criteria. Only lightweight equipment can reach the outlet structure and channel under very difficult conditions.

15. Adequacy of Access. Access to the crest of the North Branch Dam is adequate. Access to the toes of the dam is inadequate.

4. Recommended Improvements. It is recommended that Access Road "K" be cleared, grubbed and surfaced with 12 inches of gravel to meet design criteria.

7. Recommended Improvements. Access Road "I" should be upgraded to allow heavy equipment to operate on it immediately after high water events. It should be extended to meet Access Road "H". The grass on the road (approximately thirty percent of the area) should be removed and grubbed. Soft materials under the grass or along the gravel portions of the road should be removed 12 inches of gravel shall be placed on former grass portions of the road, and six inches of gravel shall be placed on the existing gravel portions of the road. A small amount of gravel may be needed to use Access Roads "J" and "L" after heavy rain and high water events.
